MAPLE LAKE DAM

NDI ID NO. PA-00766

PHASE I INSPECTION REPORT  
NATIONAL DAM INSPECTION PROGRAM

FEBRUARY 1980

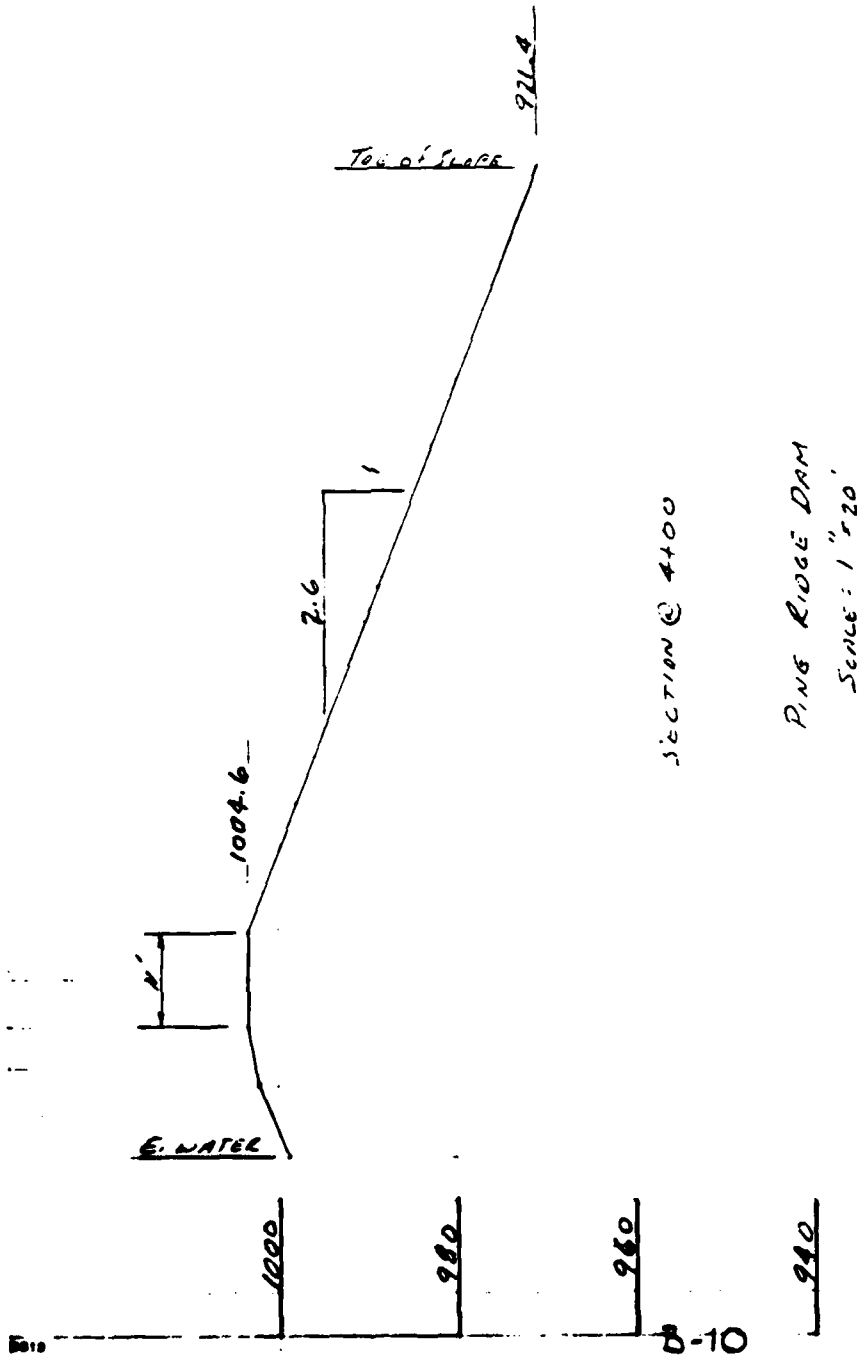
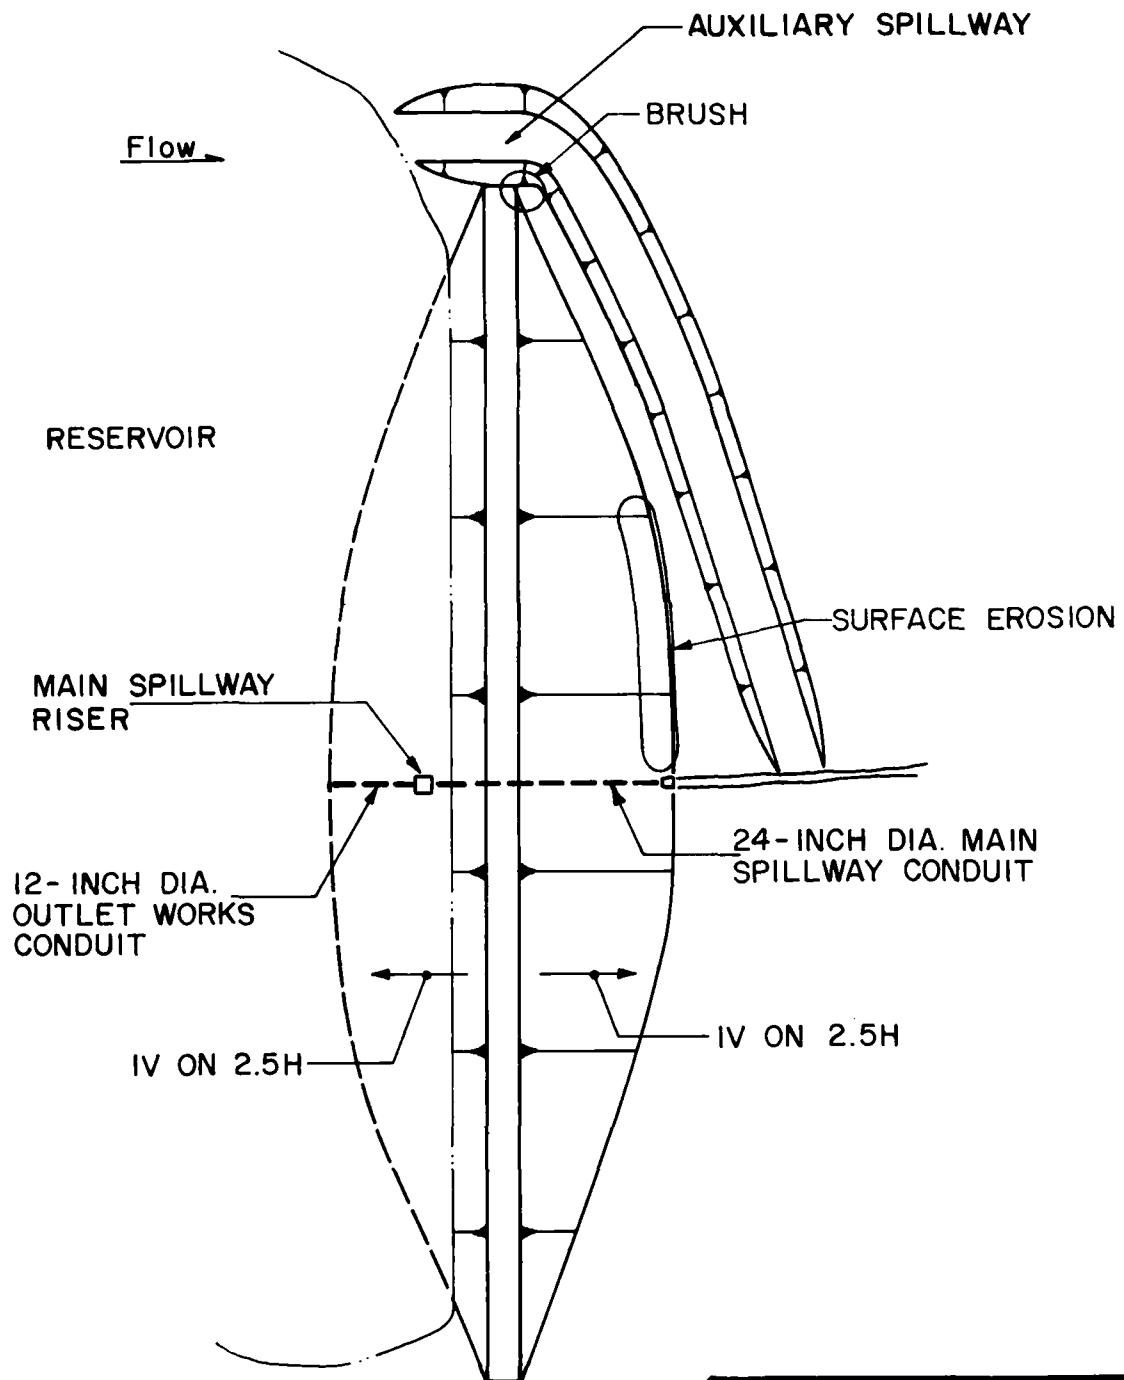
PHASE I INSPECTION REPORT  
 NATIONAL DAM INSPECTION PROGRAM  
 MAPLE LAKE DAM  
 PINE RIDGE COMMUNITY ASSOCIATION  
**RESULTS OF  
 VISUAL INSPECTION**  
 FEBRUARY 1980 EXHIBIT B-1

a. General. The overall appearance of the dam is good. Deficiencies were observed as noted below. A sketch of the dam with the locations of deficiencies is presented on Exhibit B-1 in Appendix B. Survey information acquired for this Report is summarized in Appendix B. On the day of the inspection, the pool was 0.1 foot above the main spillway crest.
